Rocky Mountain Field Institute Citizen Science Report

Niobrara Trail Restoration in the Garden of the Gods

Margaret Gaddis, owner

December 28, 2017

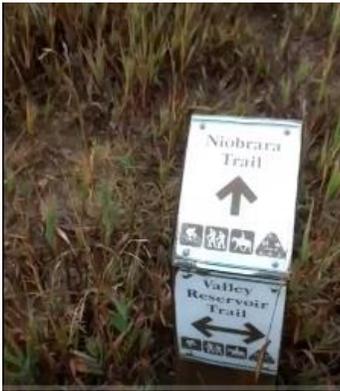
Figure 3. Watch this video to walk along the Niobrara trail: <https://youtu.be/4Y1IsbejuM4>

density is 100 times greater than that of RMNP. This likely explains trends shown here (Figure 2). These measurements indicated a deeply incised trail with excessive width. Anecdotally, the trail is difficult to travel while running or biking, which is the likely reason for evidence of switchback-cutting and social trail development (Figure 3).

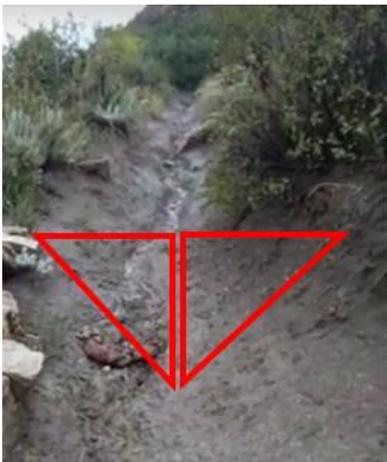
*Figure 4.* This image is a model for the cross-sectional area (CSA) soil loss measurement. The geometric area measured at each point and then averaged provides a rough estimate of the soil already lost from the trail.

I calculated an estimate of cross-sectional area (CSA) soil loss based on the width and depth measurement per point sampling. The depth and width measurements at each point constitute the two sides of a right-angle triangle (Figure 4). The area of a right-triangle can be determined by multiplying these two sides and dividing them by 2. However, we are conceptualizing two triangles, hence the width and depth measurement multiplied should complete the calculation to estimate CSA soil loss based on an estimate of eroded cubic area in the tread surface. By this calculation, the average CSA soil loss is  $5845 \text{ cm}^2$ . Svajda (2016) reported a CSA soil loss range of  $0\text{-}1510 \text{ cm}^2$  and average of  $441 \text{ cm}^2$ . The huge discrepancy between their measurements and ours is likely due to the depth of the Niobrara trail.
